Manhole Inspection Summary

Manhole # S43I__044MH

Insp Date: **4/30/08 9:15 AM**

Location Address: **1618 s bethel st**

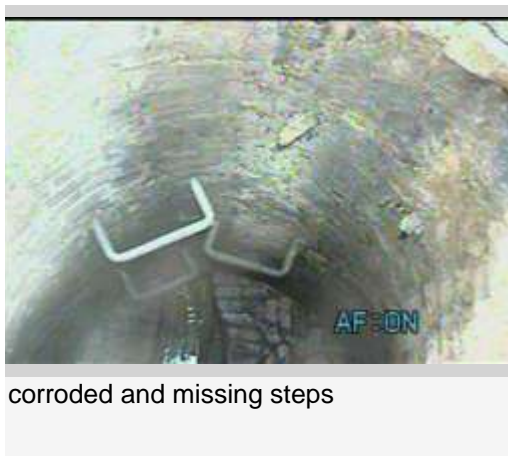
Defect 3

Count: **4** Missing: **1** ☒ **Corroded**

corroded and missing steps

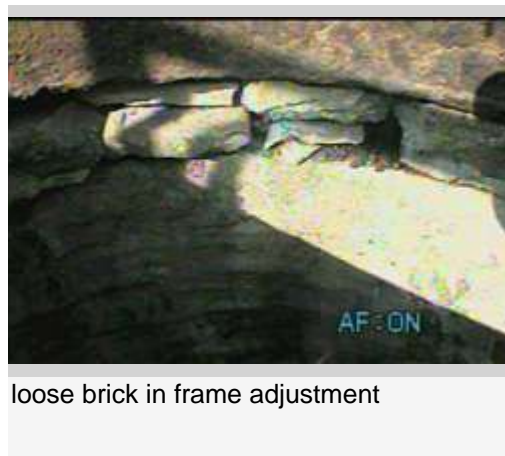
Defect 2

Condition: ☐ Sound ☐ Cracked ☐ Root Intrusion ☒ **Loose Brick** ☐ Deteriorated

loose brick in frame adjustment

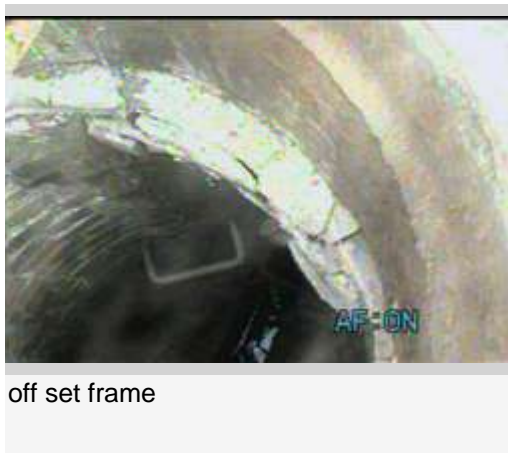
Defect 1

Offset: **2** (in.)

off set frame
